2011 Long-Term Average Annual Erosion Rate Update at Outer Banks (Corolla), North Carolina

2011 Long-Term Average Annual Erosion Rate Update at Outer Banks (Currituck Nat'l Wildlife Refuge & County), North Carolina

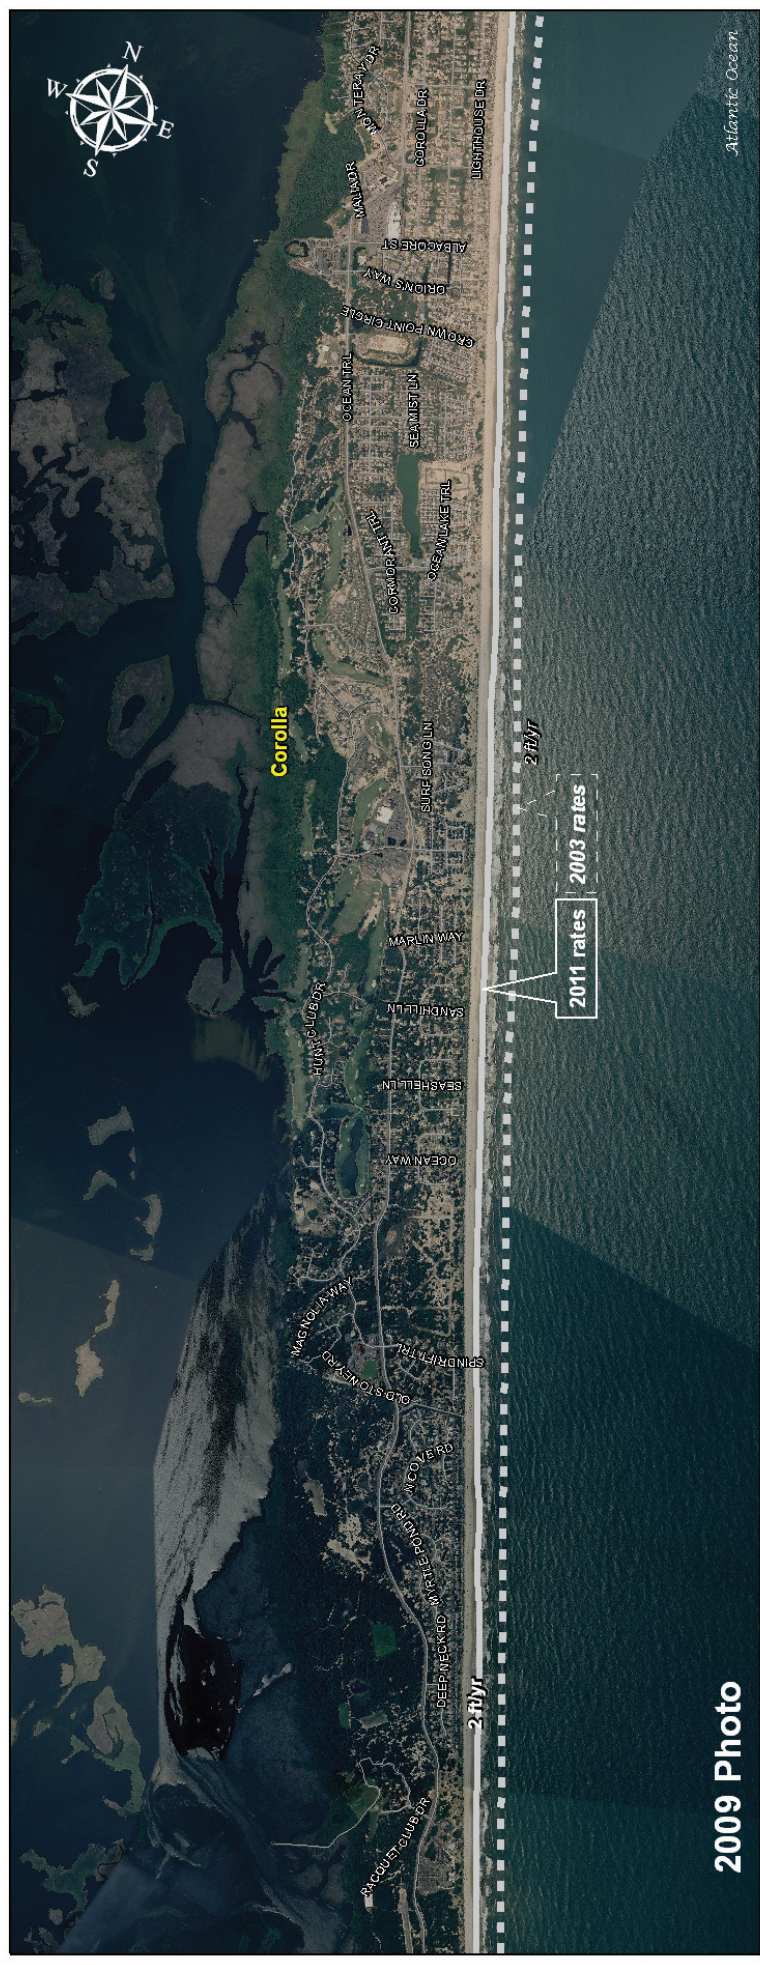
Map No. Corolla - 1 of 2

Setback Factors on this map represents long-term average annual erosion rates measured in feet per year. Shoreline segments that are accreting or have erosion rates less than two feet per year receive a setback factor value equal to two.

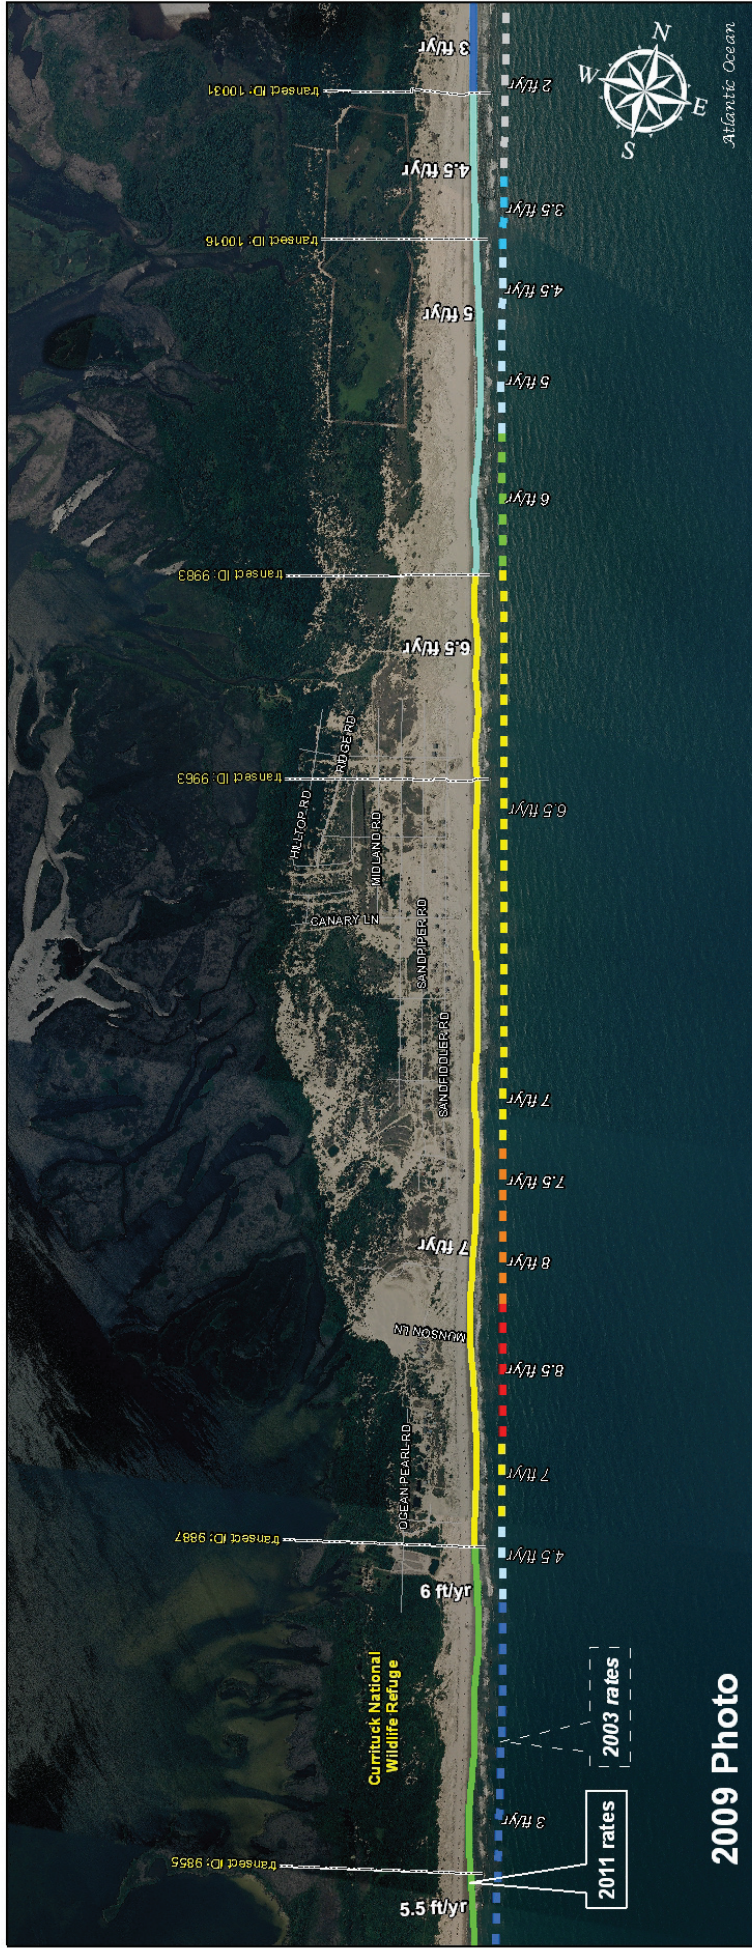
Map No. Currituck - 1 of 2

Setback Factors on this map represents long-term average annual erosion rates measured in feet per year. Shoreline segments that are accreting or have erosion rates less than two feet per year receive a setback factor value equal to two.
